Manhole Inspection Summary

Manhole # S49GG_013MH

Record Plat: **49GG** Node: **013** Status: **Found**

Insp Date: **8/11/08 11:00 AM**

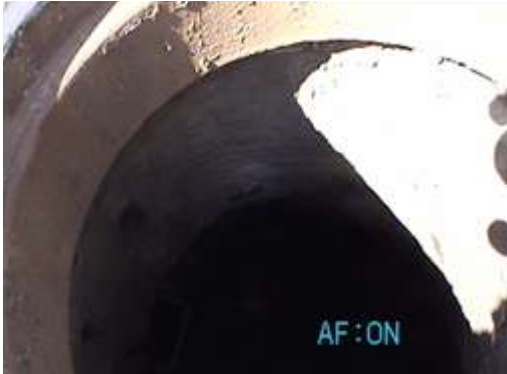
Defect 2

frame leaks

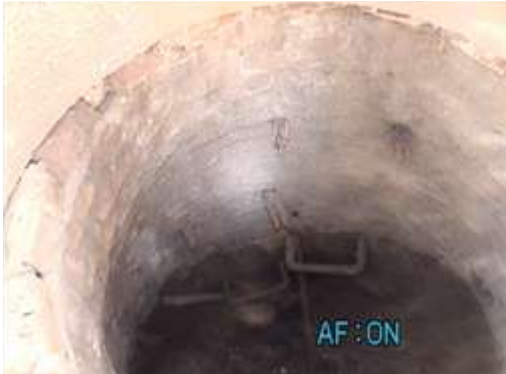
Defect 1

Infiltration

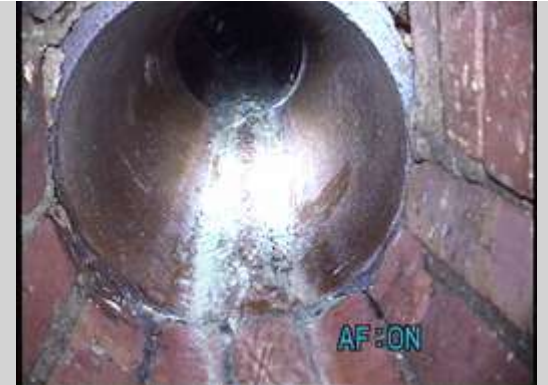
12 O'Clock Outflow

12 in. Circular Gravity Sewer
Pipe Out @ 12 O'Clock

Pipe Height: **12** (in.) Rod and Bar (Angled)
Pipe Material: **Clay** ☐ Pipe Lined
Invert Depth: **9.30** (ft.) Flow Characteristics: **Fast**
Deposits: ☒ None ☐ Mud ☐ Sludge ☐ Debris ☐ Grease
Silt Depth: (in.) Deposits Extent:
Infiltration: **None** Pipe Seal Cond: **Sound**

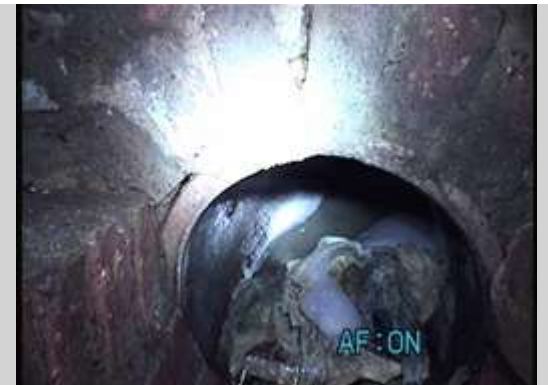
9 O'Clock Inflow

12 in. Circular Gravity Sewer
Pipe In @ 9 O'Clock

Pipe Height: **12** (in.) Rod and Bar (Angled)
Pipe Material: **Clay** ☐ Pipe Lined
Invert Depth: **8.90** (ft.) Flow Characteristics: **Fast**
Deposits: ☒ None ☐ Mud ☐ Sludge ☐ Debris ☐ Grease
Silt Depth: (in.) Deposits Extent:
Infiltration: **None** Pipe Seal Cond: **Sound**
